CGU HS Committee on River Ice Processes and the Environment
17th Workshop on River Ice
Edmonton, Alberta, July 21 - 24, 2013

River Kymijoki Ice Phenomena and Water Quality

Tom Kokkonen¹ and Matti Leppäranta²

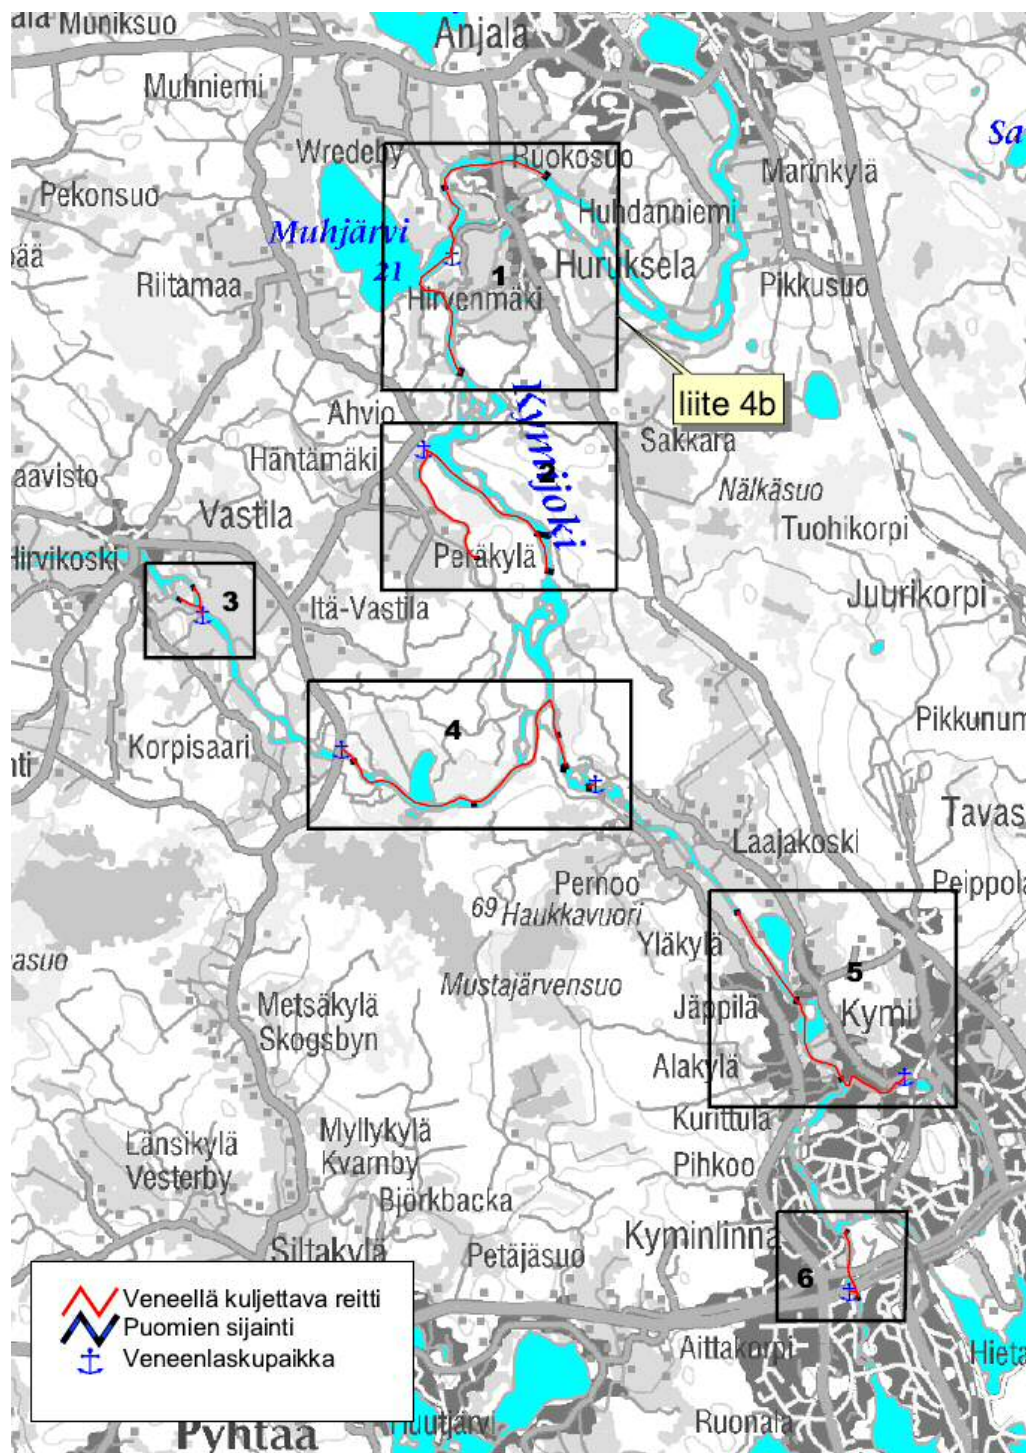
Figure 2. Frazil booms at the River Kymijoki (frazil booms are marked with black dot) (Väkevä 2004).

The measurement points were chosen so that there are points at the main branch and all of the divided branches (Figure 1). Measurement points were named from Kymi1 to Kymi11. They were also chosen so that all of different flow conditions are covered. Some of the points are in the vicinity of frazil ice booms (Kymi3, -4, -5 and -6) (Figure 2), some are at freely flowing points (Kymi2 and -7) and some of the points are at the locations of annual anchor ice problems and anchor ice blastings (Kymi5) (Figure 3).

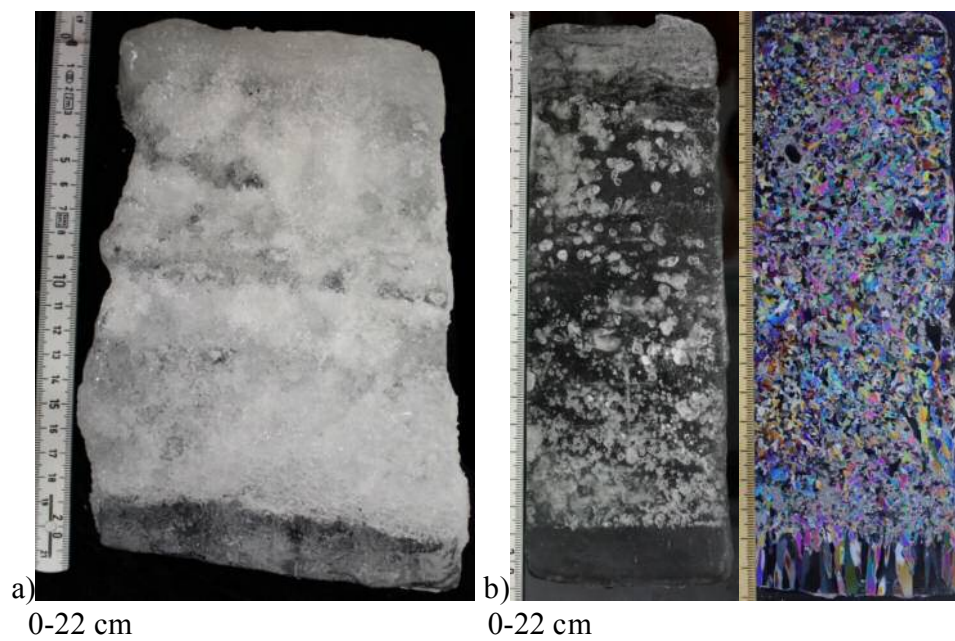
Figure 6. Kymi1 ice samples a) whole ice block, b) thick sample in normal light (left) and thin section in polarized light (right).

There was only some border ice at site Kymi1. Total thickness of the ice was 22 cm and there was 5 cm of partly melted snow on top of the ice. The ice sample was taken from the western bank of the river. The sampling site was approximately 100 meters downstream from the hydropower plant. From the full vertical ice sample in Figure 6-a it can be seen that the ice was quite opaque ice except approximately 2 cm layer of clear ice at the bottom.

It can be seen from the thick section (Figure 6-b) that the opaque layer has a lot of gas bubbles. In the top 3 cm layer there is a cloudy band where the diameter of the bubbles was less than 1 mm. Next layer (3-10 cm from top) has less gas bubbles than the top layer and their diameter is 2-5 mm. These two layers have probably formed from melted snow. The next layer (10-19 cm from top) has a lot of round gas bubbles, which diameter is approximately 1 mm. The concentration of bubbles increases to the bottom so this layer has probably formed from frazil ice that was stuck on the border of river and frozen solid. Ice has pushed impurities downwards while freezing and that's why the concentration of gas bubbles increases to the bottom. The last 2 cm layer at the bottom is clear ice with no impurities.

It can be seen from the thin section (Figure 6-b) that the top layer (0-19 cm) has a lot of small rounded and needle like grains which diameter is approximately 1-3 mm. At the bottom 2 cm layer there is congelation ice that has columnar grains. Grains are approximately 5 mm wide and 20 mm long.

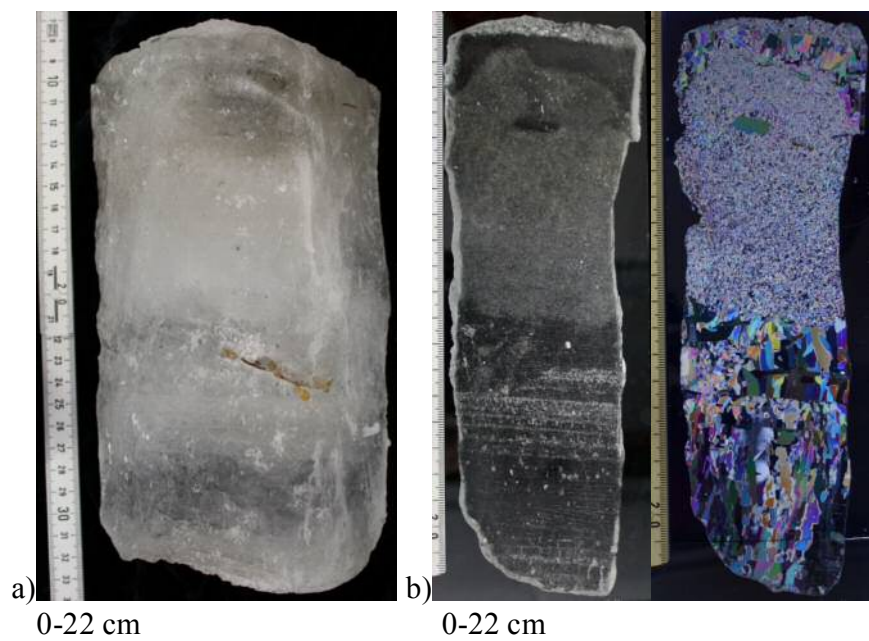
Figure 9. Kymi4 ice samples a) whole ice block, b) thick sample in normal light (left) and thin section in polarized light (right).

At the sampling site Kymi4 there was only some border ice. The total ice thickness was 22 cm and there was 10 cm of snow on top of the ice. The ice sample was taken from the southern bank of the river. Sampling site was approximately 20 meters downstream from gate-structure dam. From the full vertical ice sample in Figure 9-a it can be seen that the top 11 cm is opaque ice with a lot of gas bubbles and the bottom 11 cm is quite clear ice. There is a cloudy band layer 14-16 cm from top.

It can be seen from the thick section (Figure 9-b) that the first 11 cm contains a lot of small gas bubbles (diameter < 1 mm). There is a clear layer 0.5-2 cm from top. There are bed sediments in the layer that is 2-7 cm from top. This layer is probably the first ice layer which is formed from the frazil ice that was attached to the bottom and bed sediments stuck on it before it reached enough buoyancy to float. The bottom 11 cm layer is quite clear with few cloudy bands.

It can be seen from the thin section (Figure 9-b) that the top 11 cm has really small grains (diameter < 1 mm). This layer has formed from the frazil ice. There is a layer (0.5-2 cm from top) where there are much bigger grains (5-10 mm long and 1-5 mm wide). This layer has probably formed from the water that flooded on top of the ice. The bottom 11 cm layer is congelation ice where the grains are columnar (10-40 mm long and 1-10 mm wide).

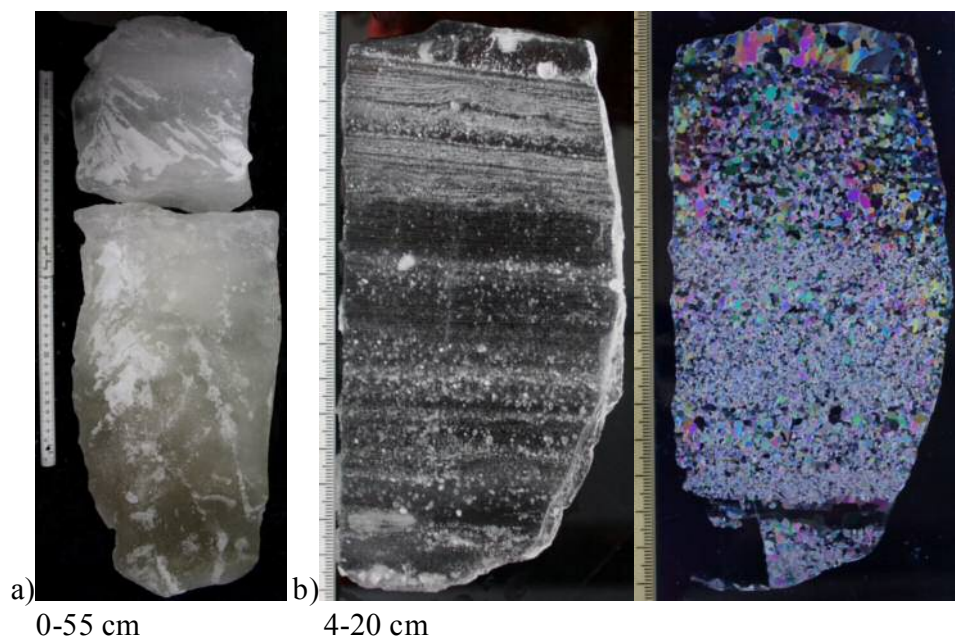
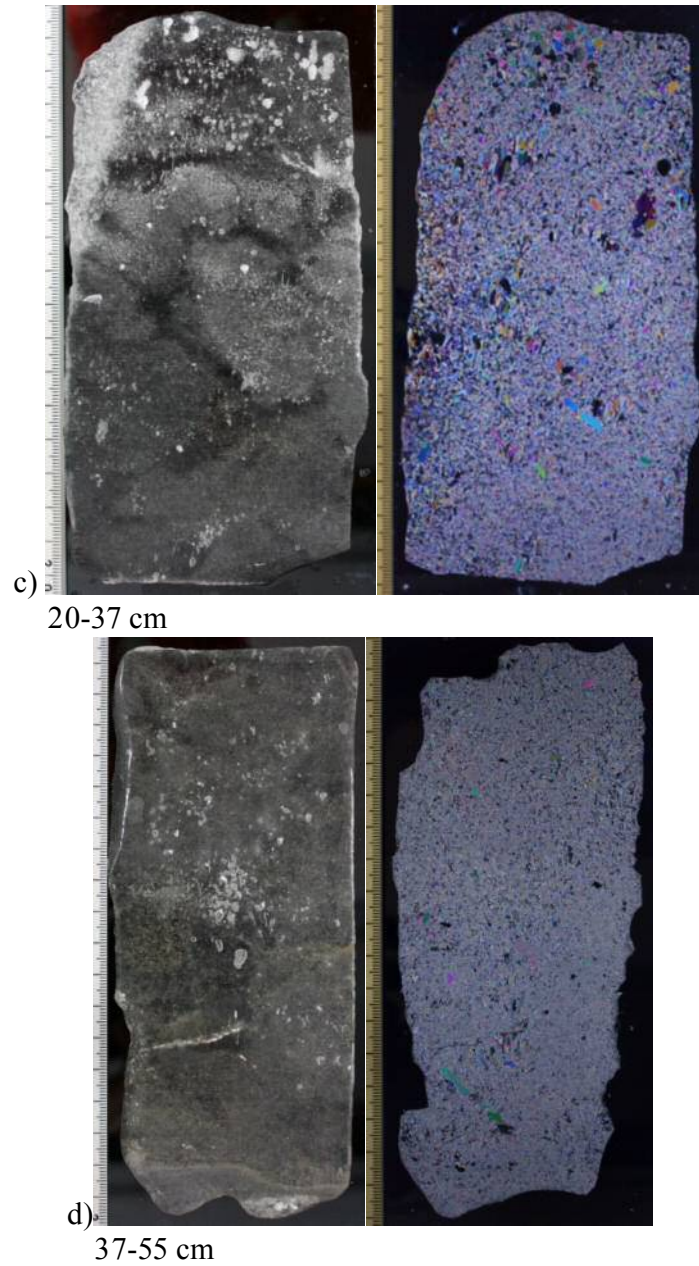
Figure 10. Kymi5 ice samples a) whole ice block, b), c) and d) thick sample in normal light (left) and thin section in polarized light (right).

At the sampling site Kymi5 there was a stationary ice cover. The total ice thickness was 55 cm and there was approximately 23 cm of snow on top of the ice. Sampling site was approximately 20 meters downstream from frazil ice boom that was broken during the winter because of high surface flow. From the full vertical ice sample in Figure 10-a it can be seen that the whole ice sample is opaque ice with a lot of gas bubbles. At the lower part of the sample (40-55 cm from the top) there are a lot of bed sediments. The ice sample broke into three pieces (0-4 cm, 4-20 cm and 20-55 cm). Top layer (0-4 cm) broke during the processing so it wasn't analyzed.

It can be seen from the thick section (Figures 10-b, 10-c and 10-d) that the top 5-10 cm layer has a lot of small (< 1 mm) gas bubbles in horizontal rows. This layer was probably formed from the snow. Next 10 cm layer has few more clear layers where is only few small (< 1mm) gas bubbles and opaque layers that has a lot of gas bubbles which diameter is approximately 1 mm. Some of these layers are probably the first ice layer and it has pushed the bubbles downwards when it froze. Rest of the ice sample has a lot of small (< 1 mm) gas bubbles which are in bunches with more clear ice in between. This layer has probably formed from the frazil flocs which froze under the solid ice cover.

It can be seen from the thin section (Figures 10-b, 10-c and 10-d) that the top layer (4-5 cm from top) has columnar grains (2-10 mm long and 1-5 mm wide). This layer has probably formed from snow that was melted because of the rain or warm weather. Next layer (5-10 cm from top) has small rounded grains which diameter is approximately 1-3 mm. Rest of the sample has really small grains (< 1 mm) that layer has probably formed from frazil ice.

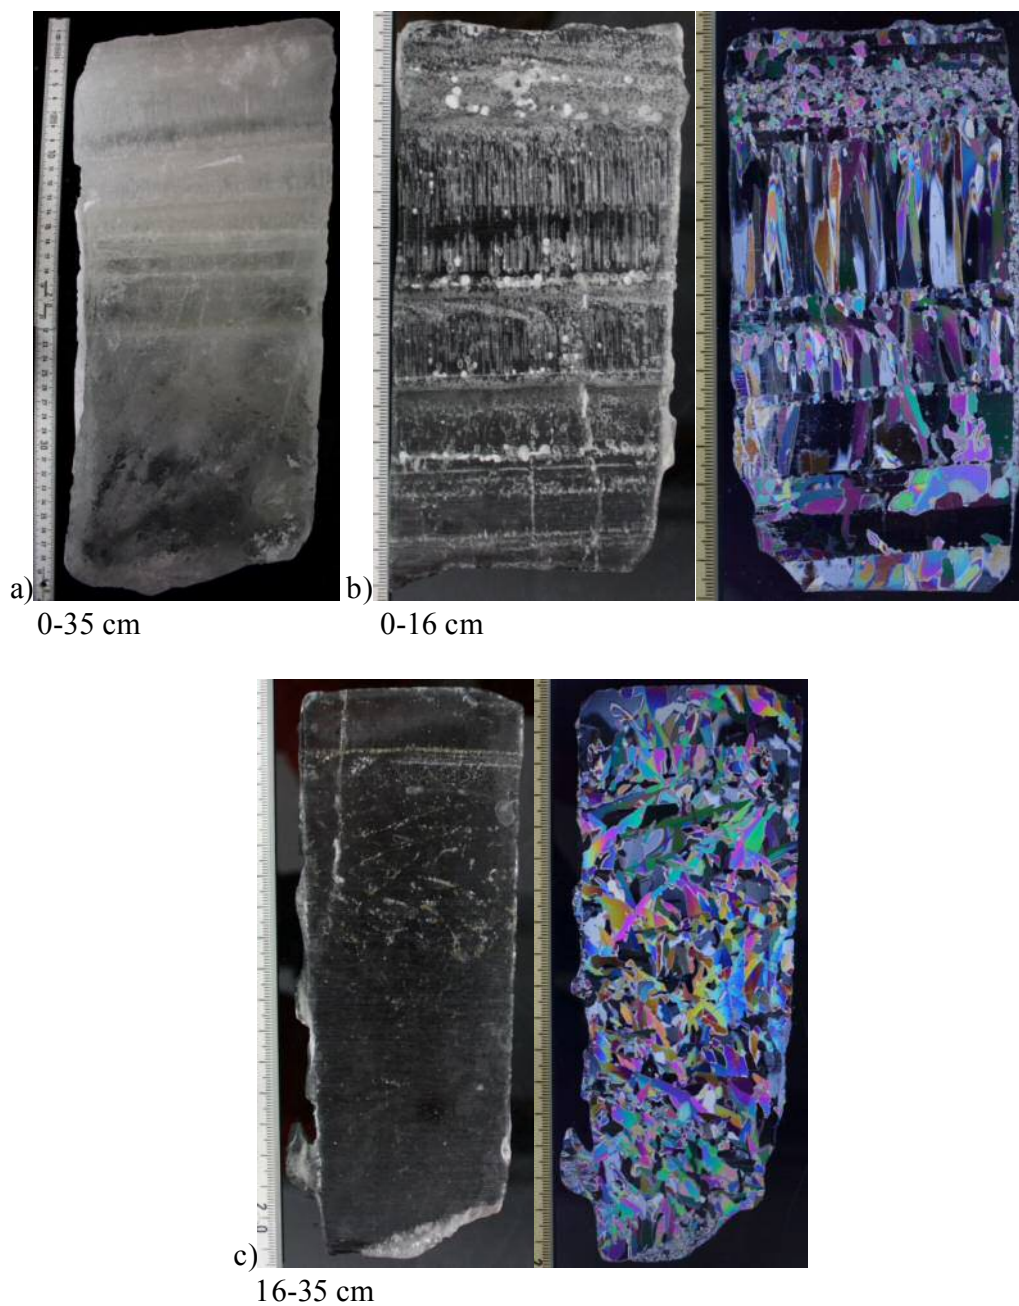
Figure 11. Kymi6 ice samples a) whole ice block, b) and c) thick sample in normal light (left) and thin section in polarized light (right).

There was a stationary ice cover at the sampling site Kymi6. The total ice thickness was 35 cm and there was 15 cm of snow on top of the ice. At the middle of the river there was some partly melted snow. From the full vertical ice sample in Figure 11-a it can be seen that the top 15 cm layer is opaque ice with a lot of gas bubbles and the rest of the ice is quite clear ice.

It can be seen from the thick section (Figures 11-b and 11-c) that the top 3 cm layer has a lot of small (< 1 mm) gas bubbles. Next layer (3-10 cm from top) has a lot of vertical gas catchments which are 3-20 mm long and 1 mm wide. These layers have formed rapidly because of really

cold temperature and ice could not push the gas bubbles away when it froze. Rest of the sample is quite clear ice with only few small (< 1 mm) gas bubbles.

It can be seen from the thin section (Figures 11-b and 11-c) that the top 0.5 cm layer has grains which diameter is approximately 3 mm. Next 0.5 cm layer has one big grain which is approximately the size of the whole layer. These layers were probably formed from the water that flooded on top of the ice or melted snow. Next layer (1-3 cm from the top) has small grains (diameter 1-3 mm). Rest of the sample is congelation ice. At the top of the congelation ice layer (3-16 cm from top) there are columnar grains which geometrical alignment is vertical. Grains are 20-50 mm long and 3-10 mm wide. There are also some frazil ice grains in between. Bottom part of the congelation ice (16-35 cm from top) has grains which are 2-30 mm long and 1-5 mm wide. Geometrical alignment is more random with these grains.
